THE ACCIDENT TO THE NRX REACTOR ON DECEMBER 12, 1952 (Part II)*

D. G. HURST

General Physics Branch
Research and Development Division
Atomic Energy of Canada Limited
Chalk River, Ontario

Report GPI-14

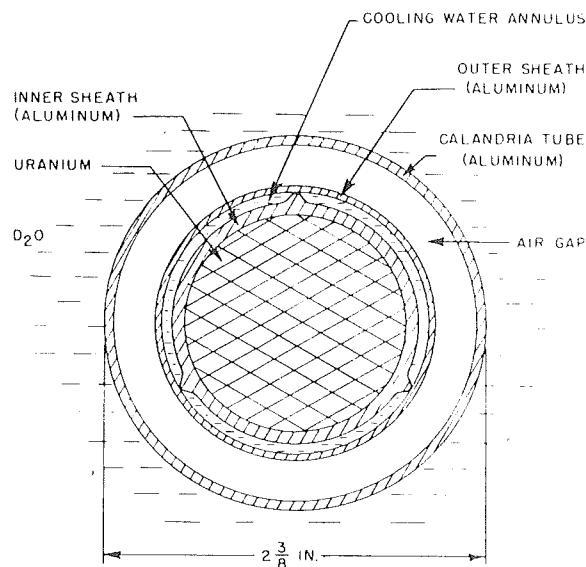
The bursting X rods punctured a number of calandria tubes, permitting the entry of light water into the heavy water and also the escape of heavy water (Fig. 1). After dumping of the heavy water was complete, the level in the storage tanks continued to rise slowly, indicating that water was running down from the calandria. The dump valves and a manually operated valve between the dump valves and

Fig. 1—Cross section of rod structure and calandria tube.

Damage may be specified roughly according to the separate or combined failures of inner sheath, outer sheath, and calandria tube (Fig. 1). Ruptures of the outer sheath are indicated in Fig. 3. These were detected by lack of pressure at the top of the rod when valved off from the top header. This information was available soon after the accident and was helpful in analyzing the leakage to the basement and as a guide in probing for more information. Damage studies were aided by an optical viewing device consisting of a mirror to be lowered into calandria tubes and an illuminator and telescope on top of the reactor. After the first few rod removals, damage was viewed and photographed (Fig. 4). In addition, a pinhole camera giving gamma-ray and optical pictures was built following a suggestion from U. S. Atomic Energy Commission and was used with particular effect in the lower header room to locate rods with excessively active ends. It was also valuable in locating "hot spots" in piping.

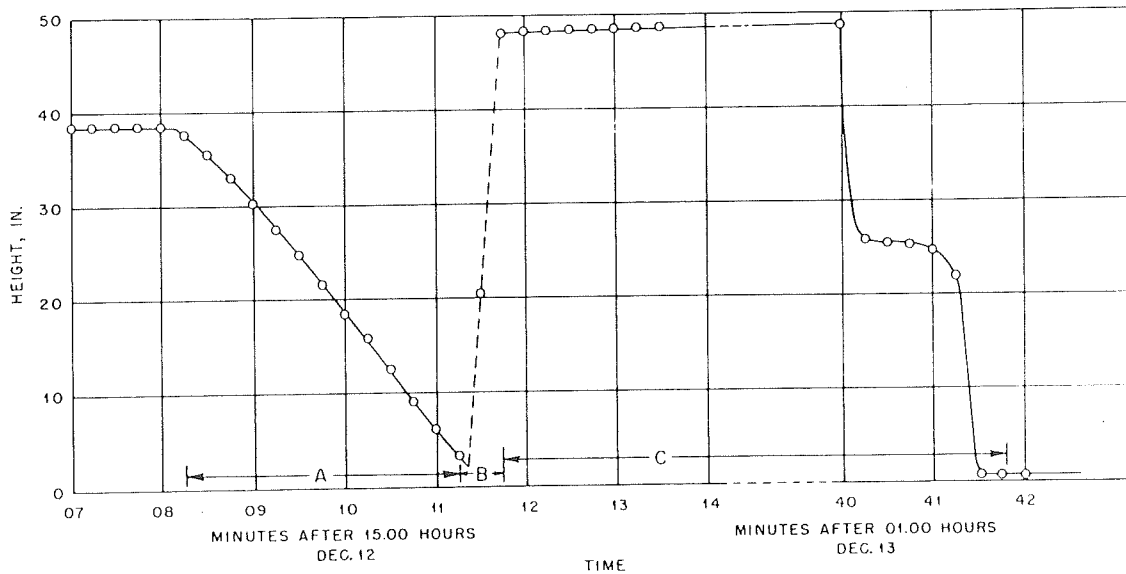
The subsequent behavior of the gasholder has not been completely explained up to this time, although a possible mechanism has been proposed. The height of the gasholder dome is recorded by a standard recorder which prints every 15 sec. Figure 2 is based on an analysis of the record.⁵ Three intervals have been marked, of which A is the steady fall occasioned by rupture of the calandria tubes. The sudden jump to 48 in. during B is the phenomenon to be explained. The long stay at 48 in. and the pause at 24 in. during C are probably due to mechanical jamming. The rapidity of descent during C could occur only if oil were missing from the seal, and this is consistent with the early observation of oil on the floor in the gasholder room.

For the dome to have been lifted in the normal manner would have required the supply of over 500 cu ft of gas within 30 sec, and no suitable source is known. An alternative explanation that the dome was blown up by an internal explosion is unacceptable because there is no way to account for the presence in the dome of an explosive mixture, nor for its ignition. Finally, we may suppose that a rapid influx of gas produced an impulsive pressure which gave the dome sufficient momentum to carry it to the top (the oil seal having blown at

Fig. 2—The record of gasholder height. The recorder printed every 15 sec at the positions marked by circles. Guide lines have been sketched in between circles.

the right moment). The natural period of oscillation of the dome very near the bottom of its travel is surprisingly short (about $\frac{1}{10}$ sec). The necessary pressure would have to build up within the first quarter cycle if the dome were free, and a very large gas flow would be required. However, if the dome is assumed to have stuck initially an impulse explanation is feasible.

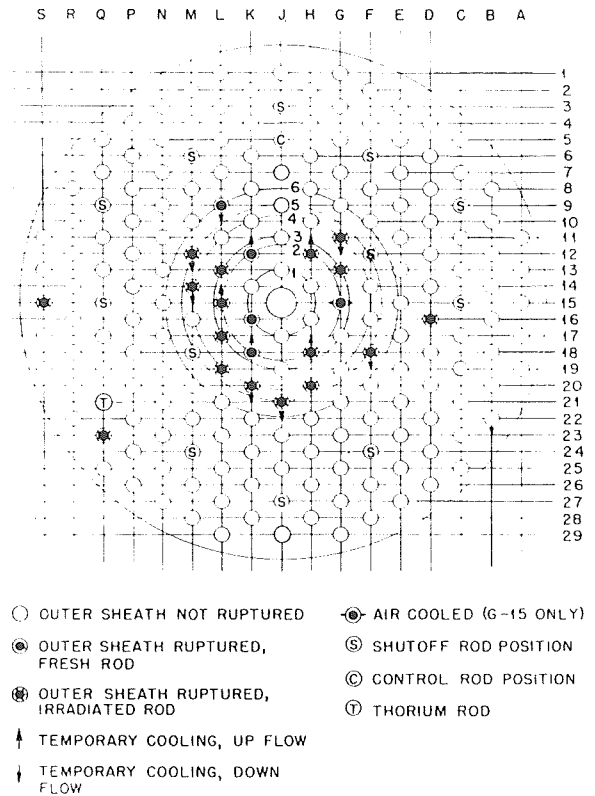
Fig. 3—A plan of the lattice. Rods with abnormal cooling arrangements are marked. With few exceptions damaged rods had ruptured outer sheaths. Some rods twisted and warped without other damage.

On a plan of the lattice (Fig. 3), the rod positions are identified by a letter and a number. They may also be assigned to concentric circles of which the first six are marked.

Certain rods (marked in Fig. 3) had temporary cooling by downward flowing water. They were supplied in parallel with normal rods through jumpers. The pressure on these rods was normal, but the flow was considerably less than normal because of the restriction by the jumpers.

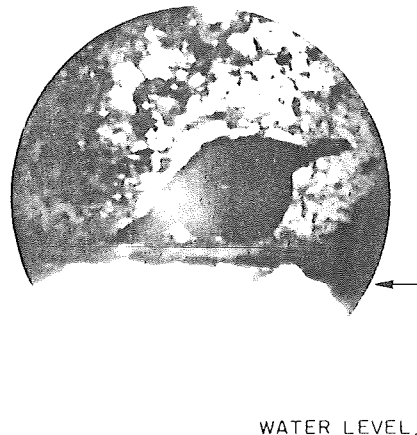
Fig. 4—A view looking east at water surface inside calandria tube M-14 photographed through a viewing device. Actual size is $1\frac{1}{2}$ in. in diameter. At the middle of the field of view is a diamond-shaped hole through which the vertical edge of a neighboring tube can be seen. The white segment at the bottom is water which filled the tube above the remaining uranium.

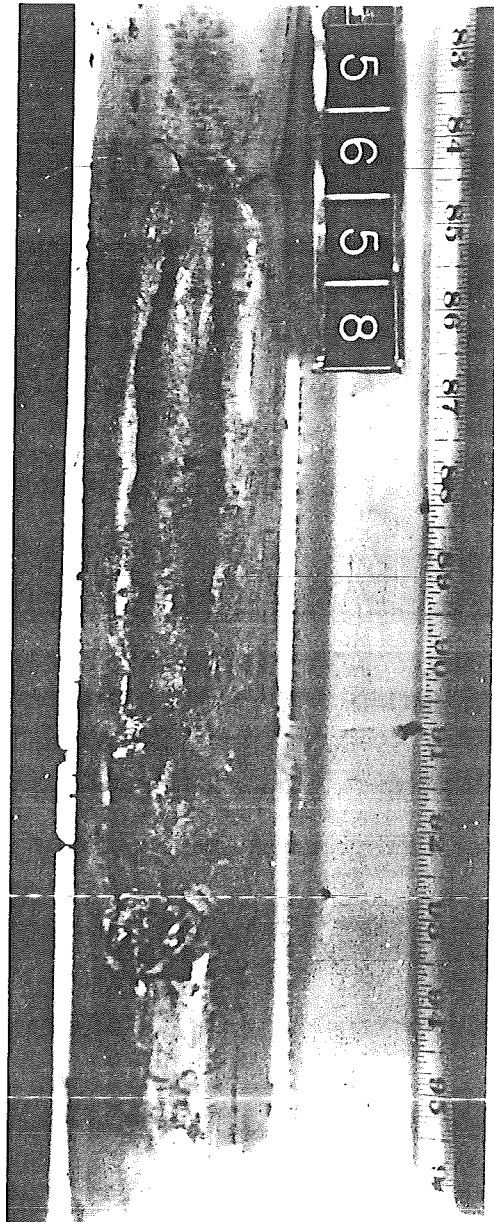
Fig. 5—The center portion of a normally cooled rod from circle 3 (G-13). After the rod was removed, viewing of the calandria tube revealed pits and stains but no major damage. This is an example of what a calandria tube can withstand. The irradiation at the center was 760 mwd/ton.

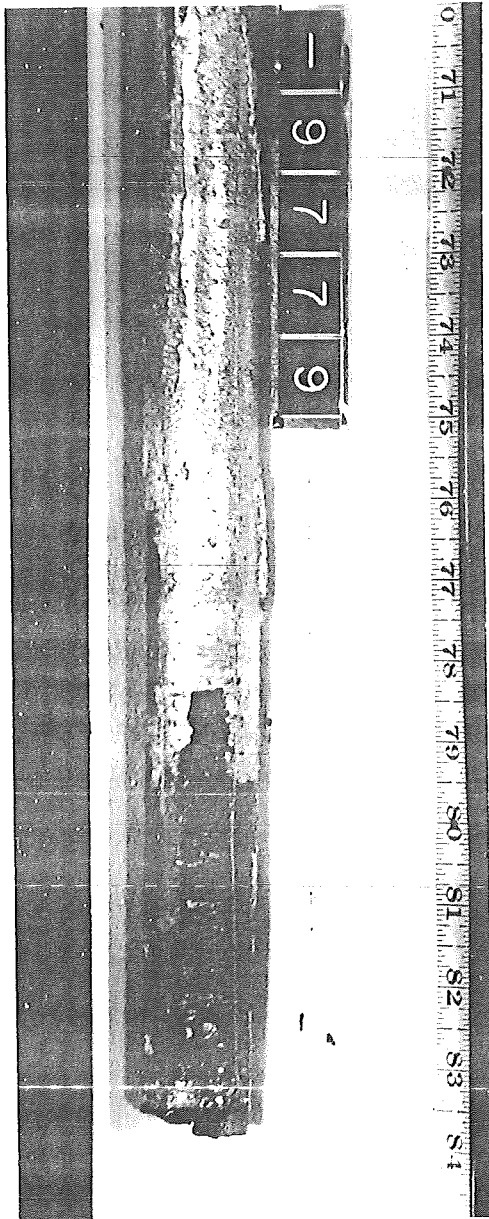
Fig. 6—Part of a normally cooled irradiated (1000 mwd/ton) rod from circle 4 (L-19). At the top the inner sheath can just be seen. Below that most of the aluminum has sloughed off, leaving a coat of aluminum-uranium alloy on the rod. Lower still, where the heat was greater, the uranium appears oxidized, but the aluminum is still present in the surface layer.

A number of instances occurred of a behavior seen in a previous failure. This is the formation on the uranium of a protective coating of aluminum alloy when the aluminum sheath has melted. The alloy extends from the aluminum melting zone but disappears where the temperature has been much higher (Fig. 6).

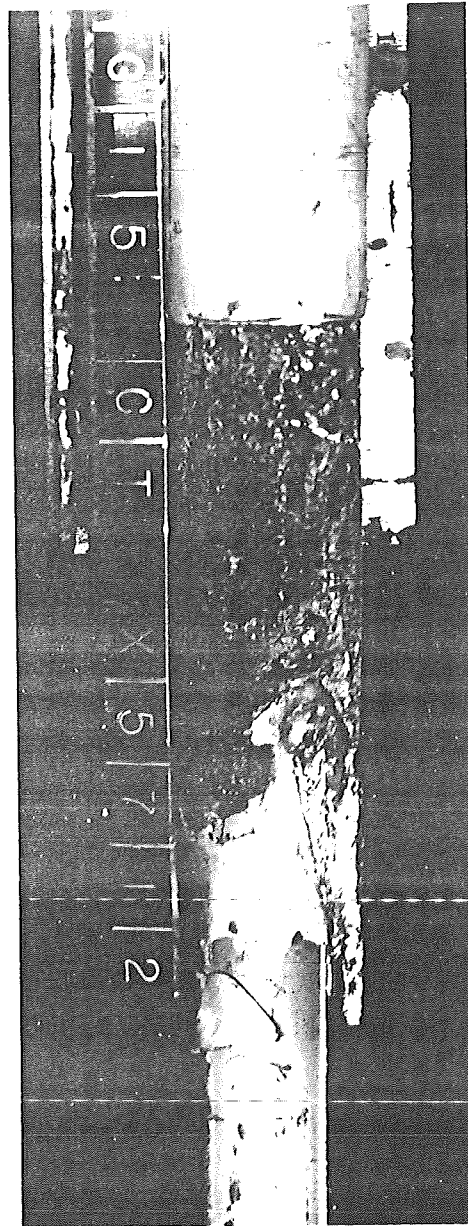
Fig. 7—Lower part of the air-cooled rod from G-15. Starting at the bottom is undamaged inner sheath, then melted and crumpled aluminum. Above that is a dark mass, apparently uranium and uranium oxide, which molded itself into the calandria tube, a few inches of which appear at the top, the remainder having been cut away.

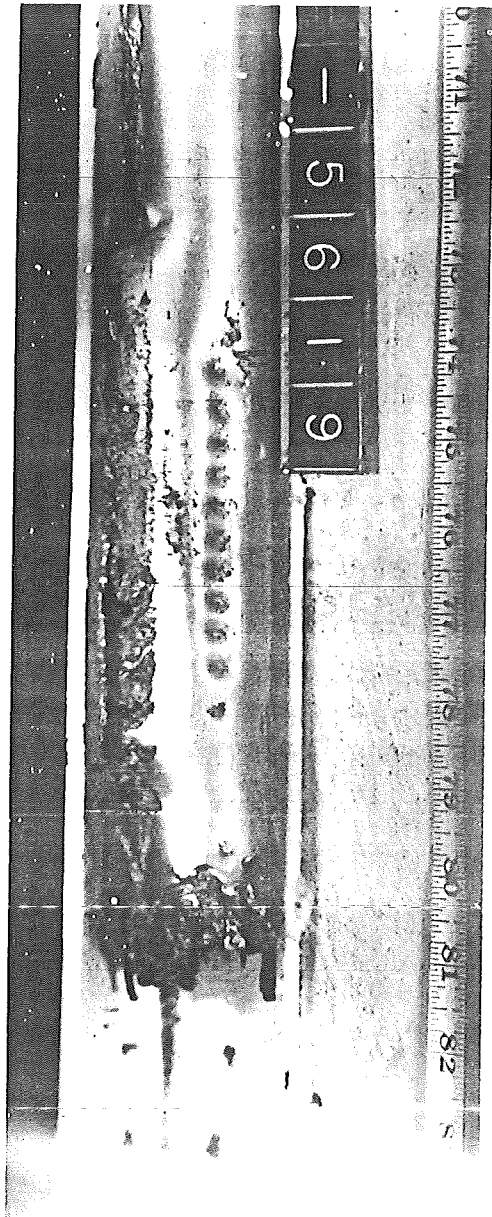
Fig. 8—The calandria tube just above the position of maximum flux in a temporarily cooled rod in circle 6 (L-9). The rod had not been previously irradiated. Evidently at the lower end only a shell remains. A dark coating covers the inside of the greatly distended calandria tube. The regularly spaced marks were made during removal to squeeze the tube back towards normal size.

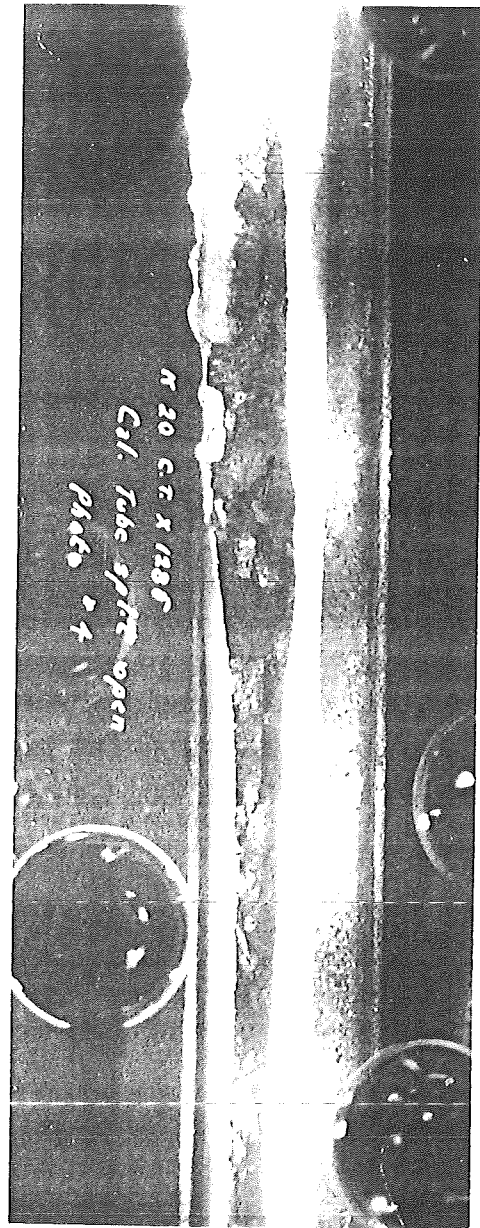
Fig. 9—Part of calandria tube K-20 above the level of maximum damage. (From circle 4, temporary cooling, center irradiation of rod 1450 mwd/ton.) The tube has been split longitudinally to reveal the contents, which bear no resemblance to the original rod assembly.
